M/V STELLAR DAISY LIFE RAFT

VISUAL SURVEY REVIEW

Job Number: OIL-19-STLR-0001
Document Number: OIL-19-STLR-RP-1004

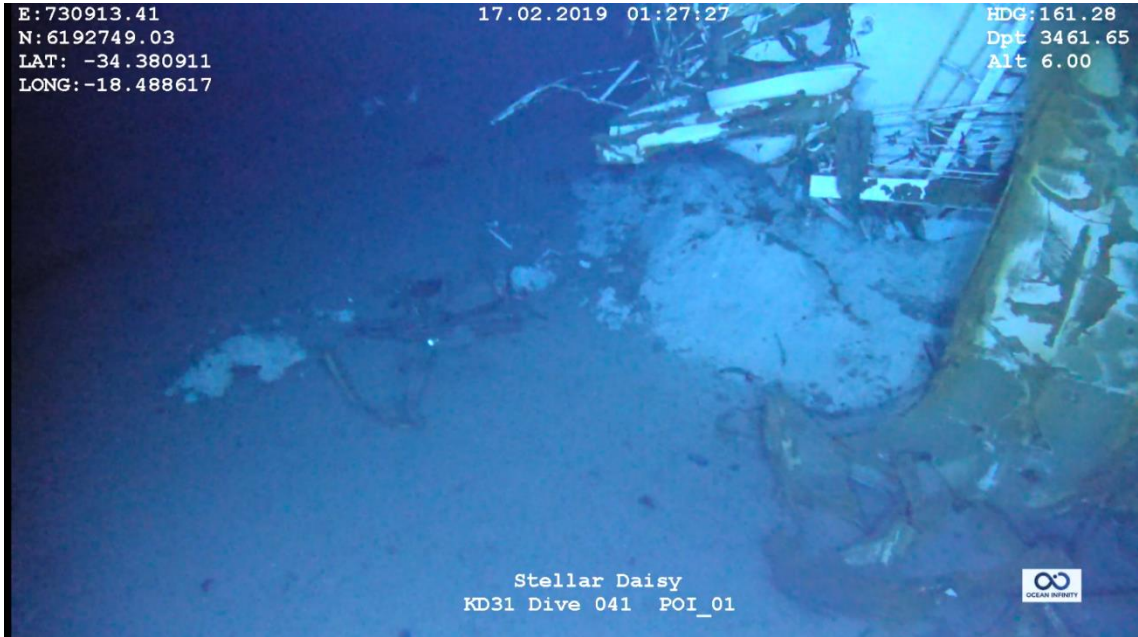
A copy of the General Arrangement drawing observed in the *Stellar Daisy Casualty Investigation Report* (2019) records that there are six levels of bridge superstructure above deck (Figure 4-2). In the video footage the superstructure of the vessel is seen to be standing more or less upright on the seabed, but only the upper three levels are visible. It is evident that the lower section of the bridge superstructure, particularly on the starboard side, is buried in the seabed and iron ore material. Figure 4-3 is an example of such burial on the starboard side. The lower levels are also crushed from the impact & weight of the structure above. Figure 4-4 is an example of the crushed lower level on the port side.

Figure 4-3; ROV image of starboard side of the superstructure highlighting burial of lower structure in the seabed / iron ore material

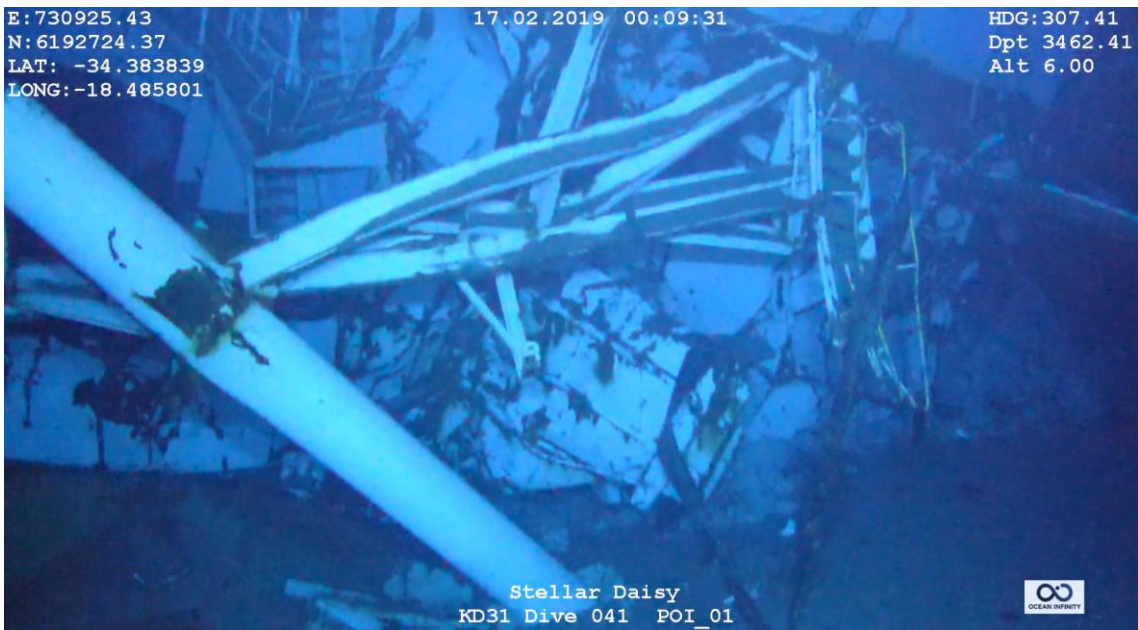
Figure 4-4; ROV image of port side of superstructure highlighting crushing of lower level(s) of the superstructure

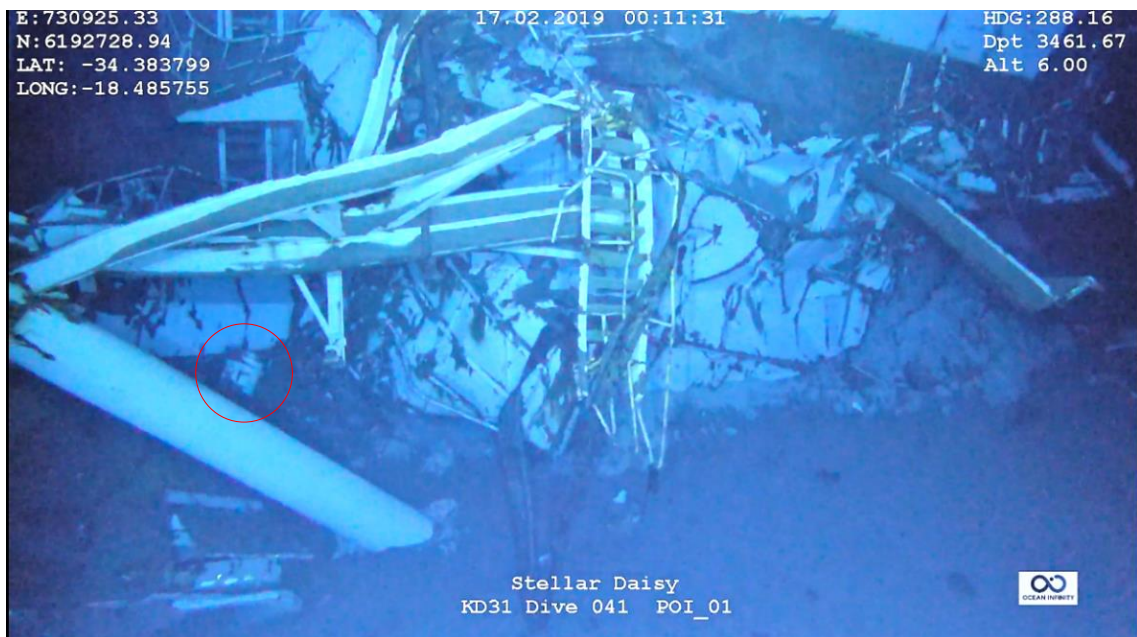
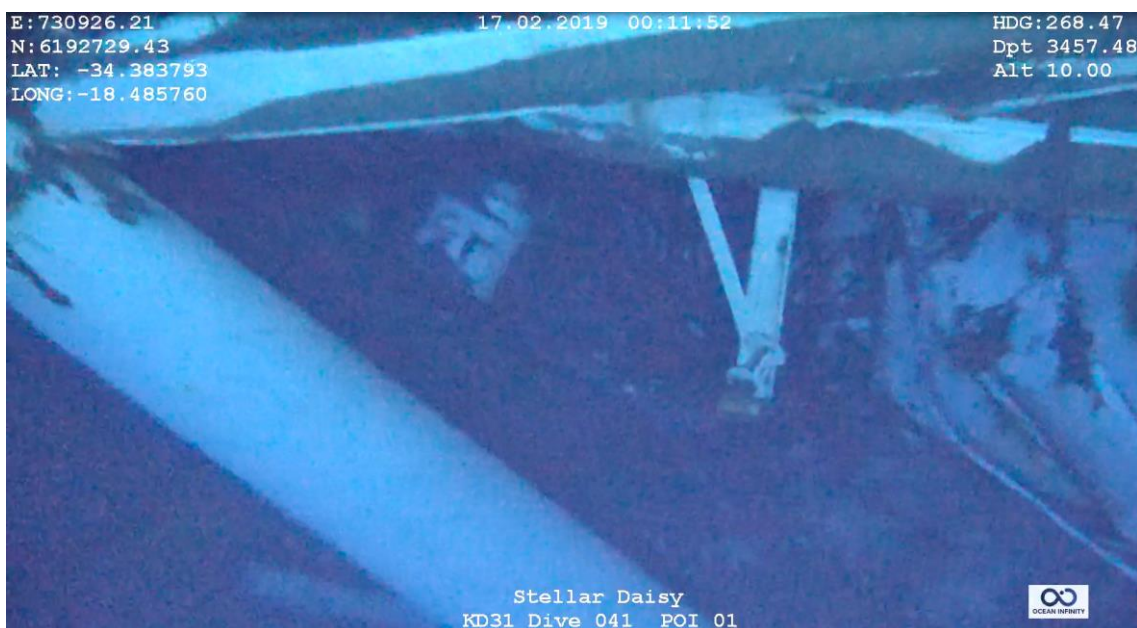
In video clip 20190217000630207@DVR-STBD_Ch1.mp4; a portion of a semi-buried white cylindrical object can be seen adjacent to the vessel superstructure (Figure 4-5, Figure 4-6). This object is located under the remains of the port side bridge wing (fly bridge), which is close to the location of the life rafts defined in the recently supplied data (Figure 3-3). The object is located at approximately E730909, N6192719 (Figure 4-1). It is visible on the ROV video clip recorded on the 17/02/2019 from 00:11:30 to 00:12:02.

Figure 4-5; ROV image showing location of Object 1 (highlighted) adjacent to superstructure on port side.

Figure 4-6; ROV image close-up of Object 1 - adjacent to superstructure on port side

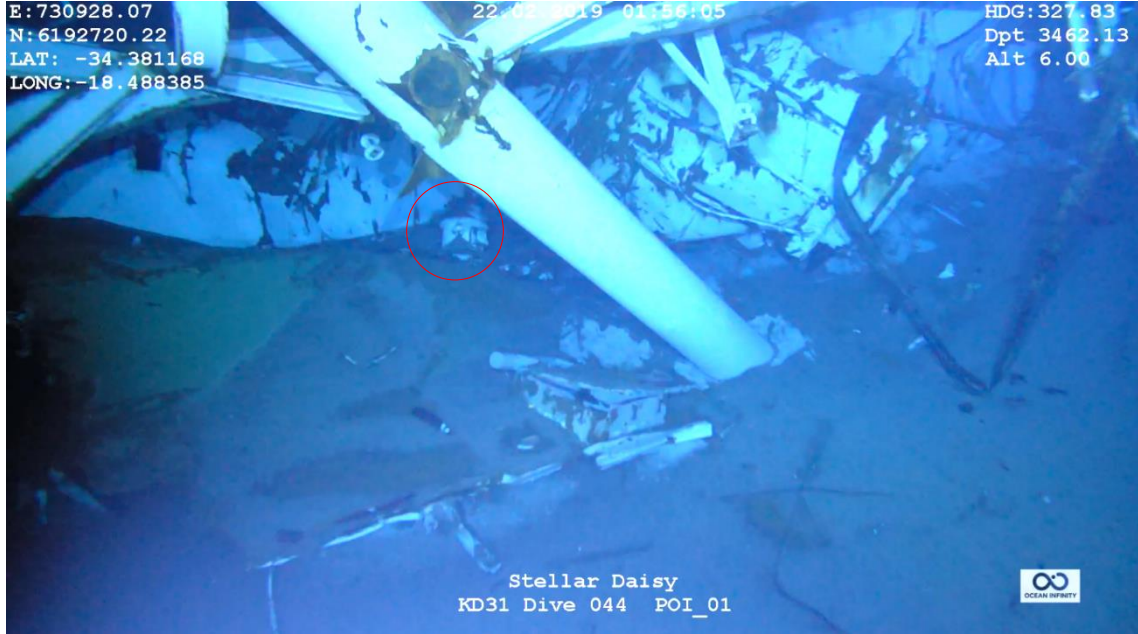
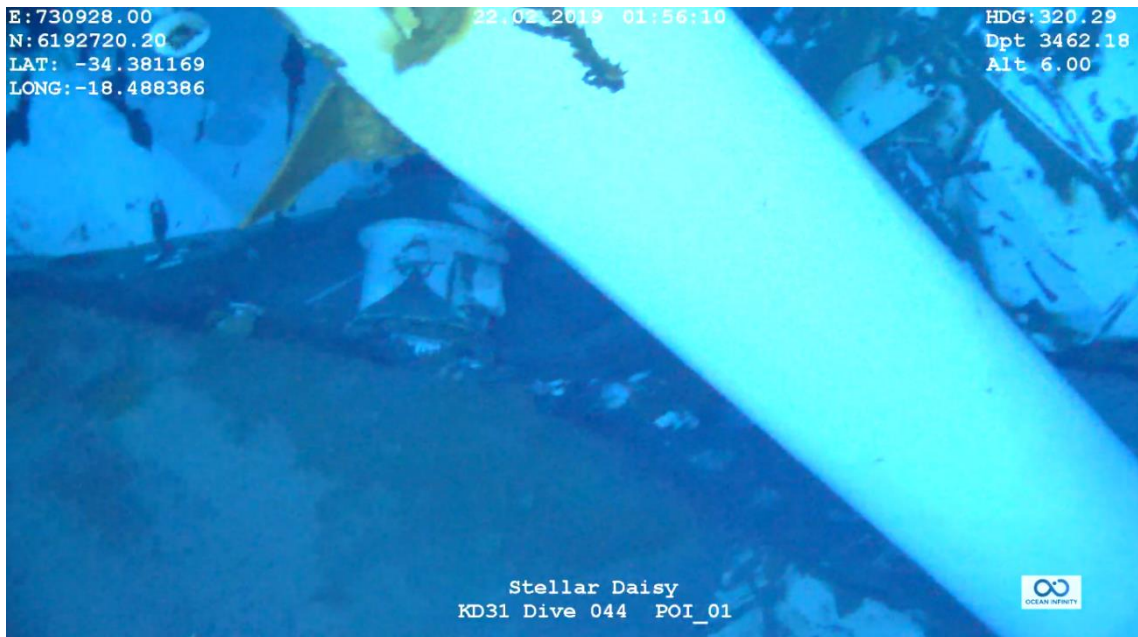
The object was also seen on the HR visual survey conducted on the on the 22/02/2019 on video clip 20190222014417191@DVR-STBD_Ch1.mp4 at 01:56:16. This footage offers a view from a different angle but is still inconclusive (Figure 4-7, Figure 4-8). It is difficult to ascertain the size of the object from a distance.

Figure 4-7; ROV image of general area of Object 1

Figure 4-8; Close-up ROV image of Object 1

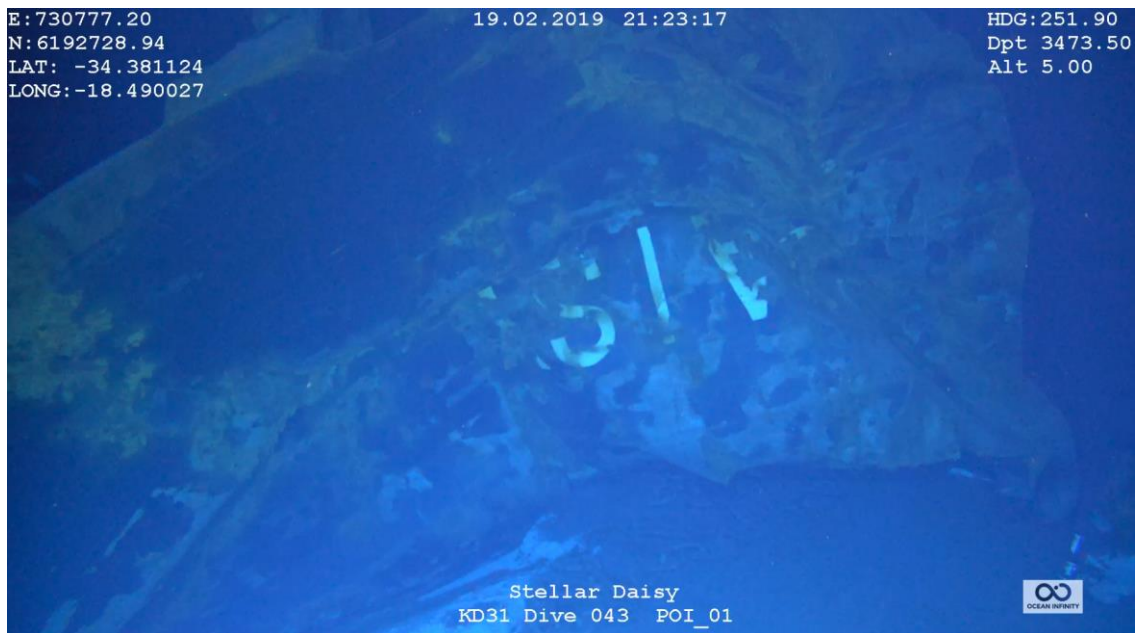
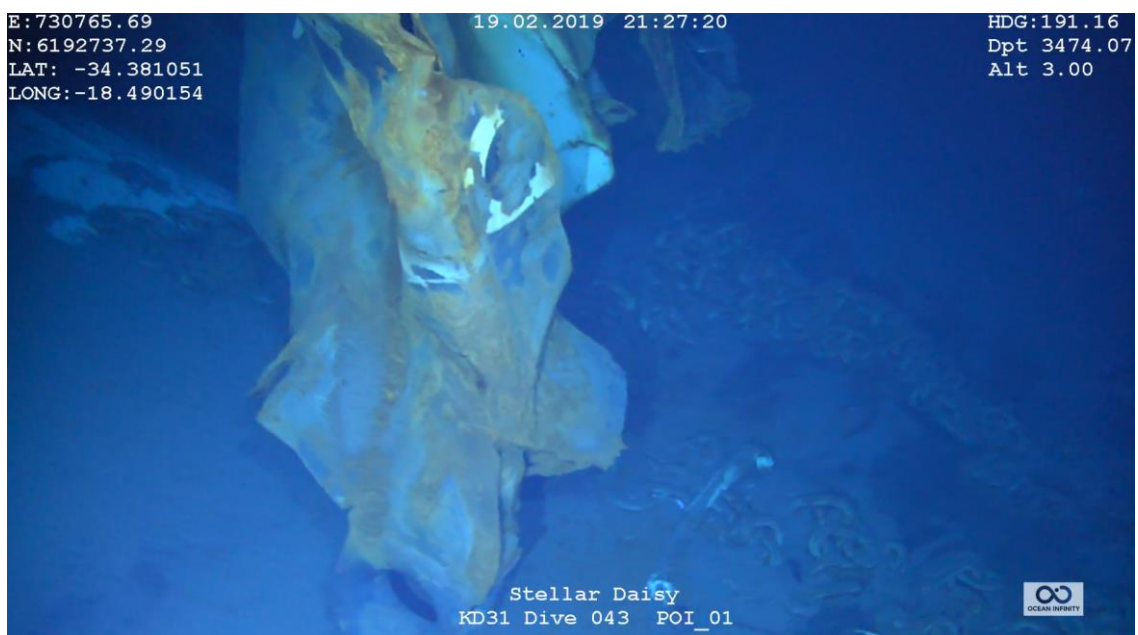
The ROV footage of the previously identified bow section has been reviewed on the video clip 20190219210542177@DVR-STBD_Ch1.mp4. The exact location where the life raft would have been fitted has not been identified. Given the condition of the steel (mangled and twisted) which makes up the former hull; it is difficult to see how a fibreglass life raft case could be still in position or intact, in the event that it failed to deploy. Example images below illustrate the condition of the bow section.

Figure 4-9; ROV video image illustrating the condition of bow section

Figure 4-10; ROV video image illustrating the condition of bow section

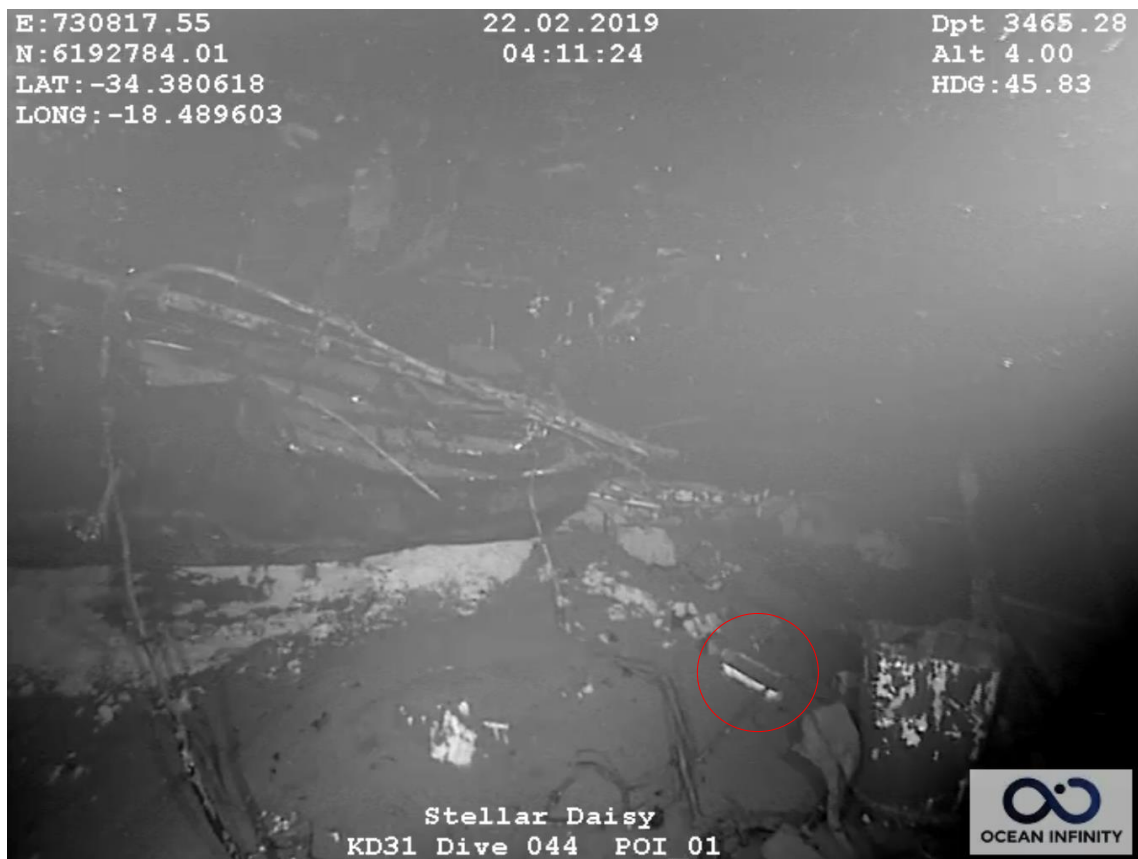
During the HR survey an object was observed at approximately E730816, N6192789 in an area with other wreckage, including large sections of the hull (*Figure 4-11*). The object is white, half of a cylinder, hollow and partially filled with iron ore (*Figure 4-12*, *Figure 4-13*). It resembles the discarding casing (half section) of a life raft housing. It was observed on ROV video clip *20190222034421197@DVR-STBD_Ch1.mp4* located in folder *DATA_20190222034421197* on the 22/02/2019 between 04:11:19 and 04:14:07.

Figure 4-11; ROV Black and White video image showing an overview of the area in which Object 2 is located. Object 2 is highlighted in red.

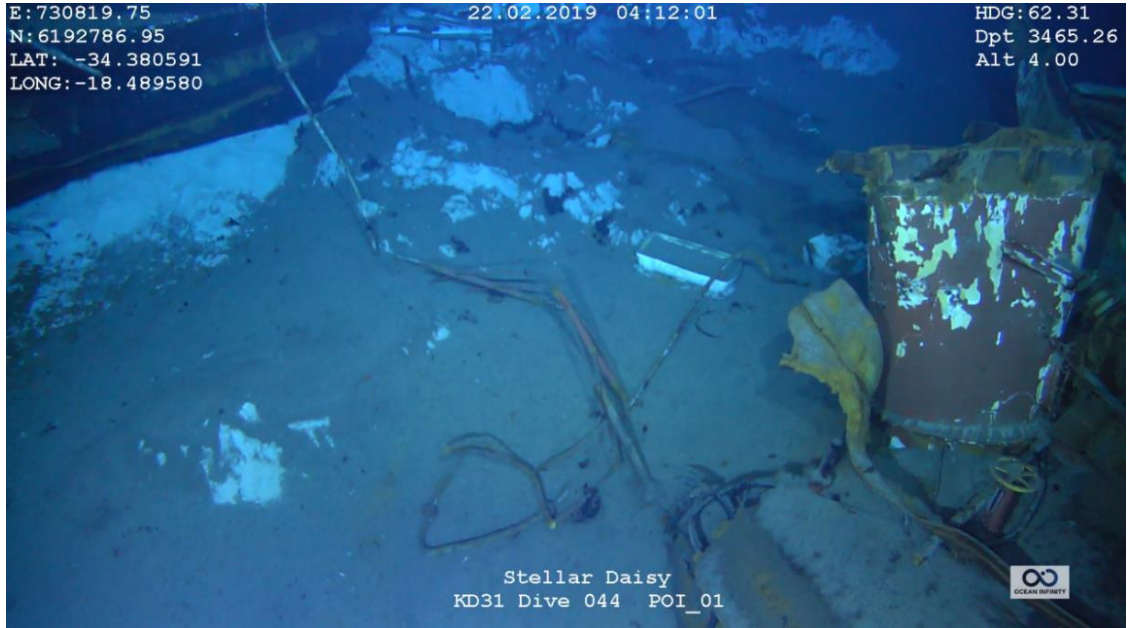
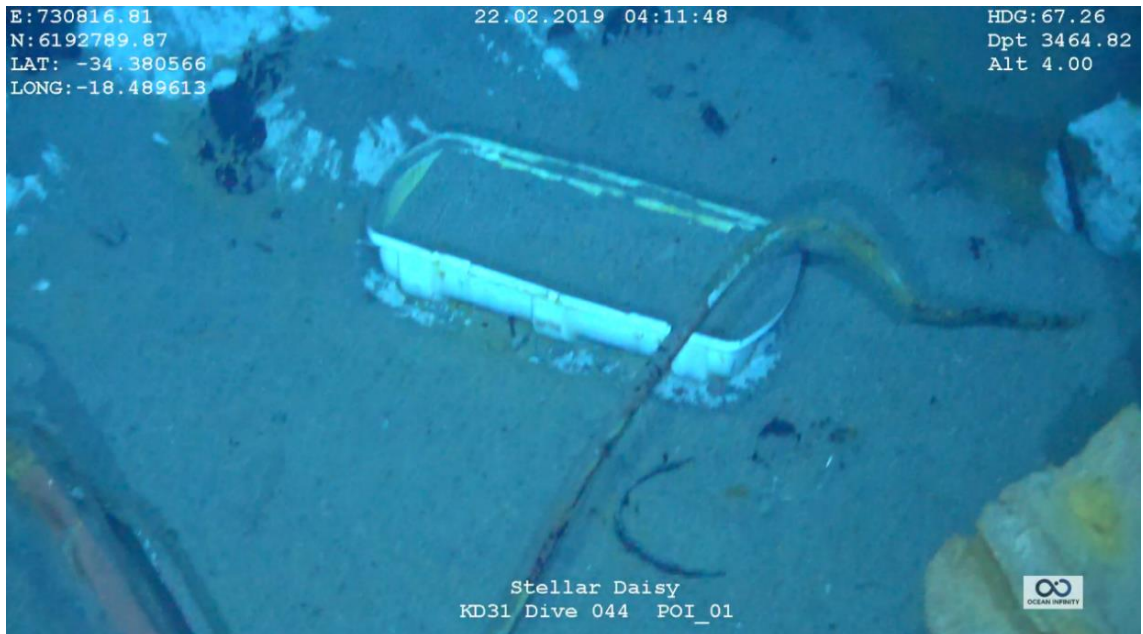
Figure 4-12; ROV video image of the area in which Object 2 is located

Figure 4-13; ROV video image close up of Object 2

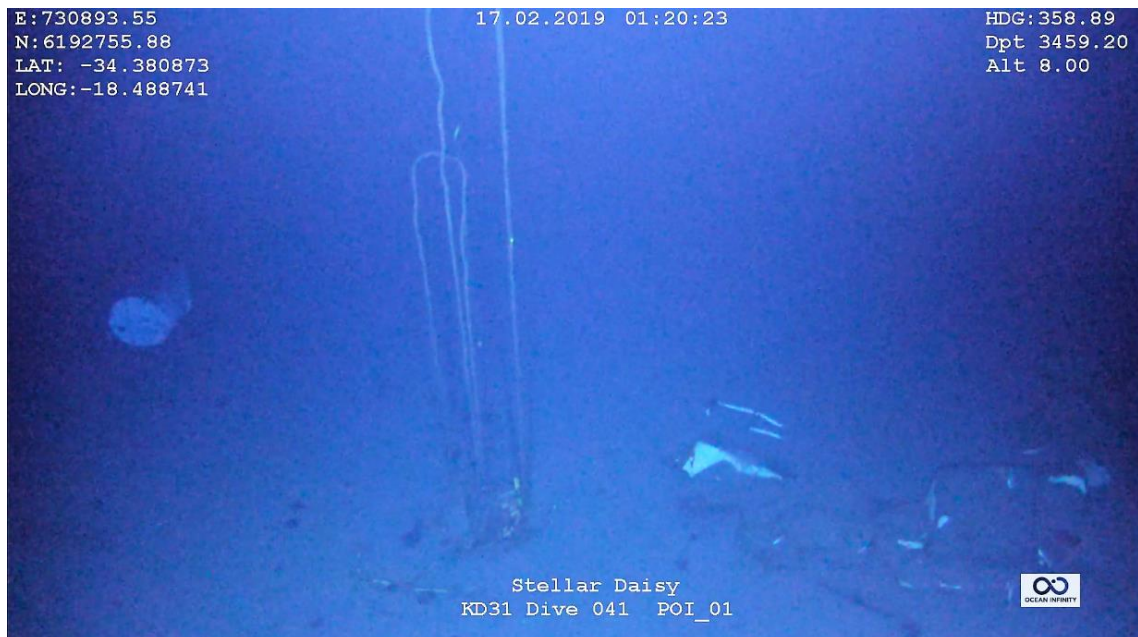
In video clip 20190219032502183@DVR-PORT_Ch1.mp4 - a white cylindrical object can be seen on the seabed 40m north of the vessel superstructure (*Figure 4-14*). The cylinder is located at approximately E730892, N6192779 (*Figure 4-1*). From a distance the object resembles a life raft case, but later footage from the HR survey shows that it is a hot water tank/boiler (*Figure 4-15, Figure 4-16*). It is visible on the ROV footage recorded on the 19/04/2019 at 03:47:23.

Figure 4-14; ROV video image overview of Object 3, located in left middle-ground

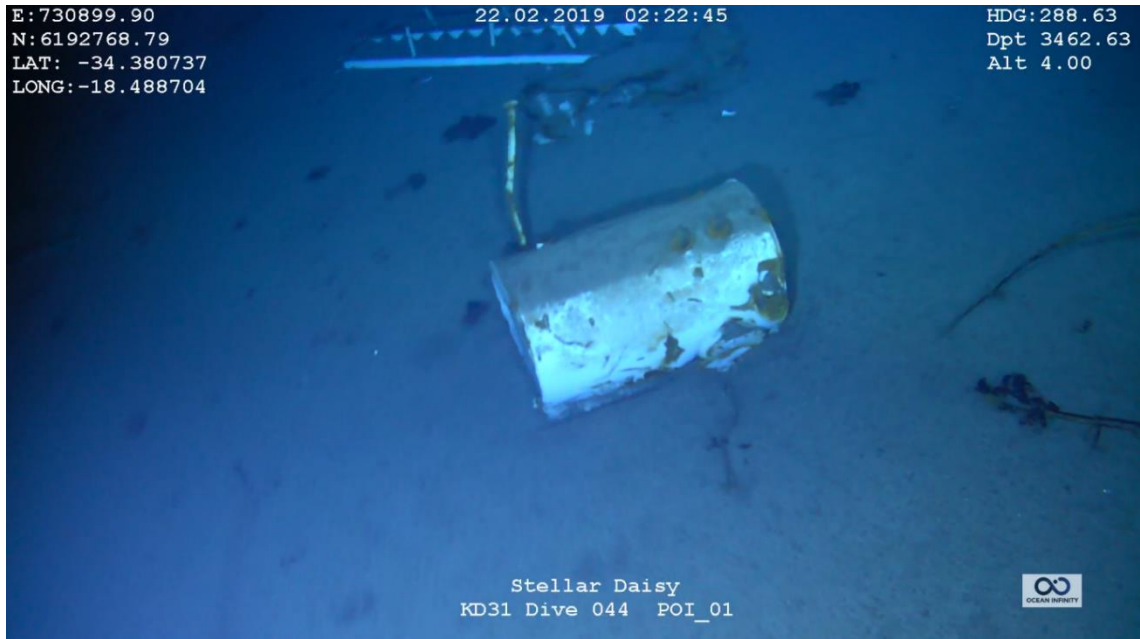
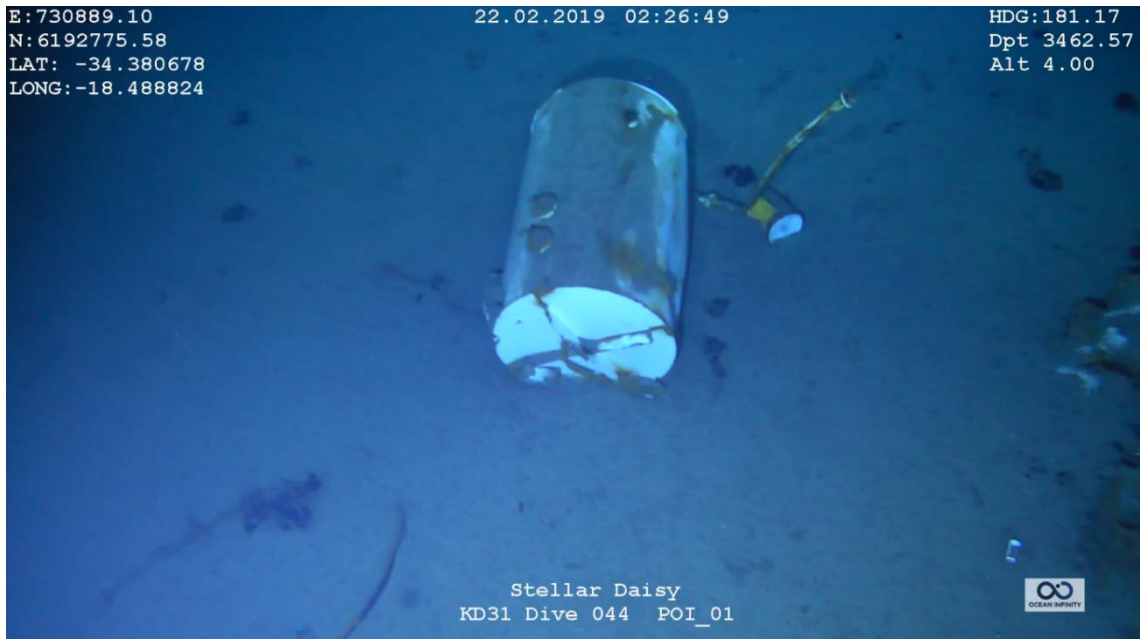
The cylinder was seen more clearly during the HR survey on the 22/04/2019 (*Figure 4-15, Figure 4-16*). It was seen in close-up at 02:22:45 and 02:26:49 on video clip 20190222021418180@DVR-STBD_Ch1.mp4.

Figure 4-15; ROV video image close-up of Object 3

Figure 4-16; ROV video image close-up of Object 3
