M/V STELLAR DAISY LIFE RAFT

VISUAL SURVEY REVIEW

Job Number: OIL-19-STLR-0001
Document Number: OIL-19-STLR-RP-1004

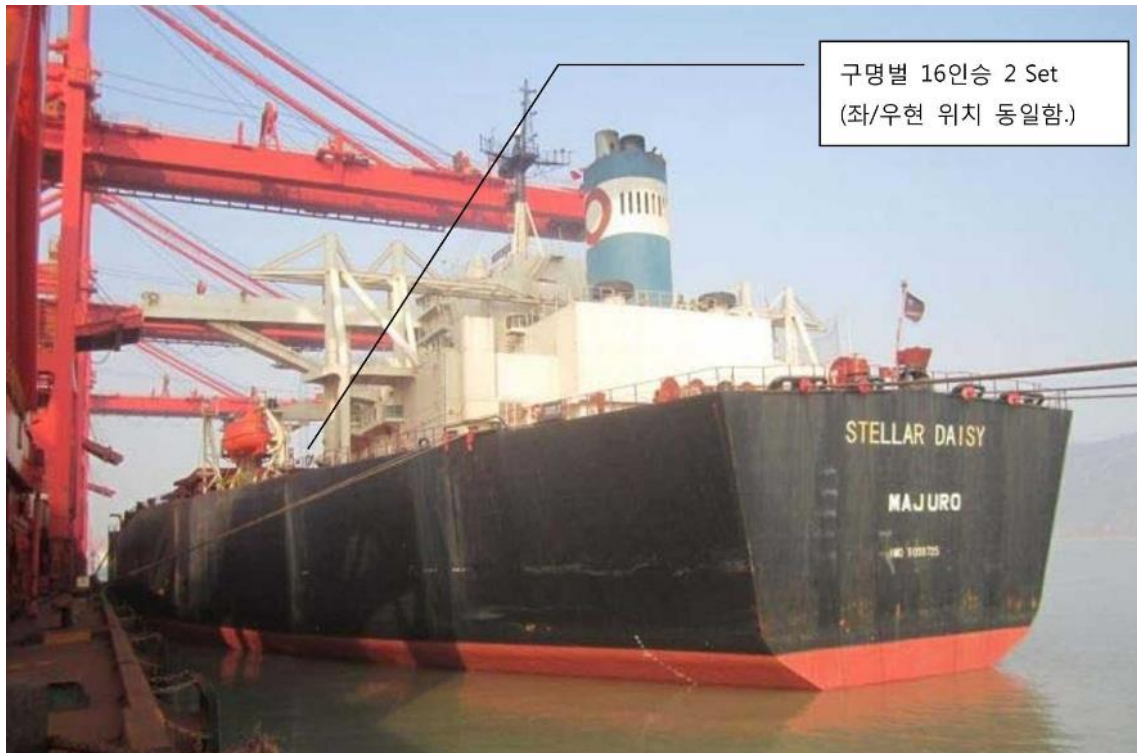
Figure 3-2; Client supplied annotated image highlighting life raft location on deck level - aft of lifeboat on port side

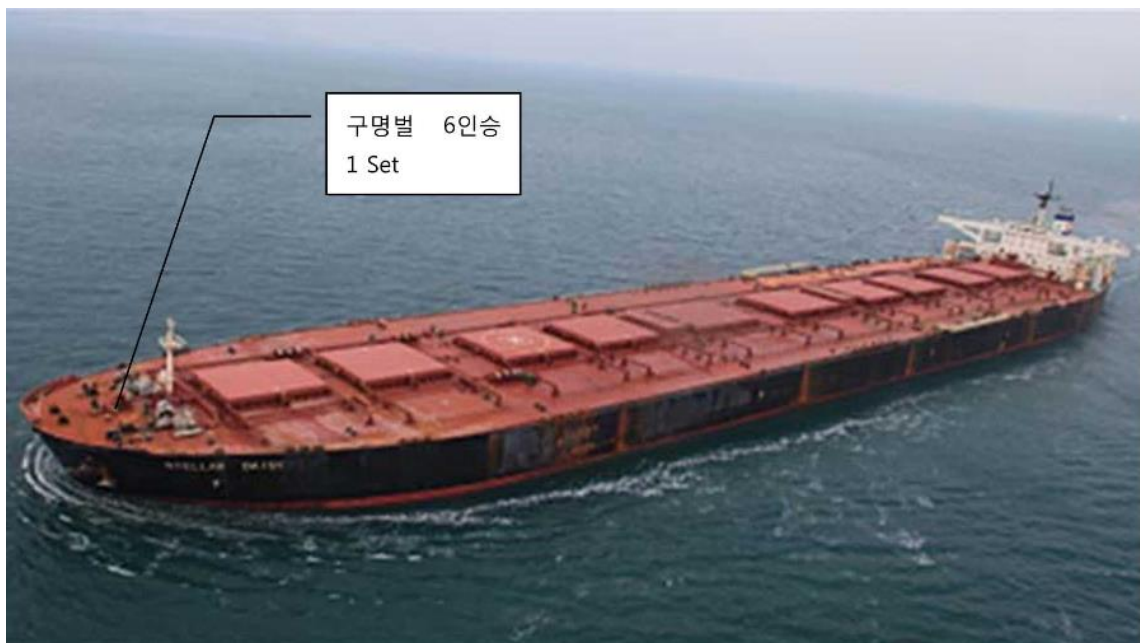
The Client supplied plan of the life rafts (Figure 3-3) shows that a 5th life raft, a smaller 6 person raft, was mounted forward; on the deck ahead of the bow mast. A Client supplied annotated image also places it in this position (Figure 3-4). According to the *Stellar Daisy Casualty Investigation Report* (2019) the forward life raft was not required to float free (footnote 142, PG 44).

Figure 3-4; Client supplied annotated image highlighting life raft location on deck level at the bow, fore of the bow mast

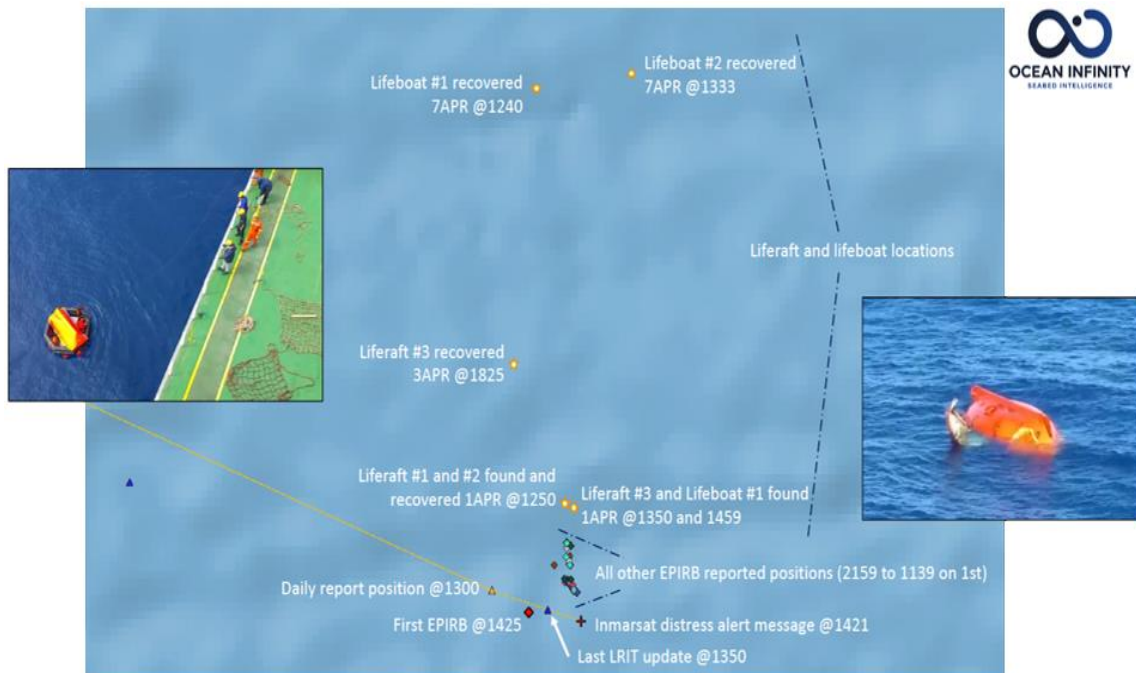
Two damaged and partially capsized life boats and three life rafts were recovered from the water during search and rescue operations between the 1st and 3rd of April 2017 (Figure 3-5). The remaining two life rafts were not found. The question remains as to whether or not they were deployed by manual or hydrostatic release or if they went down with the vessel.

Figure 3-5; Locations of life boats and rafts recovered during SAR operations from the 1st to the 3rd of April 2017. Source: Ocean Infinity

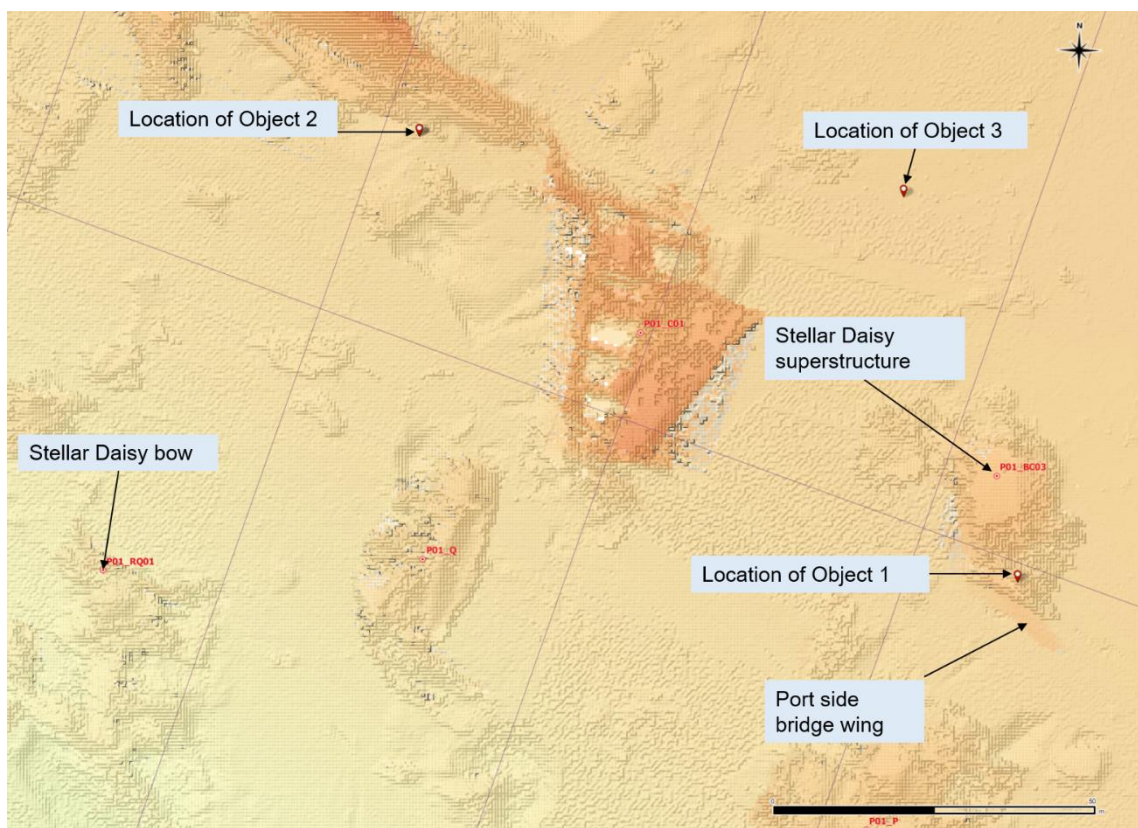
Figure 4-1; Locations of M/V Stellar Daisy bow and superstructure within debris field. Locations of three relevant objects also highlighted
